Navajo Abandoned Uranium Mine

Site Screen Report

Harry Walker No. 16 AUM Site

Navajo AUM Western Region

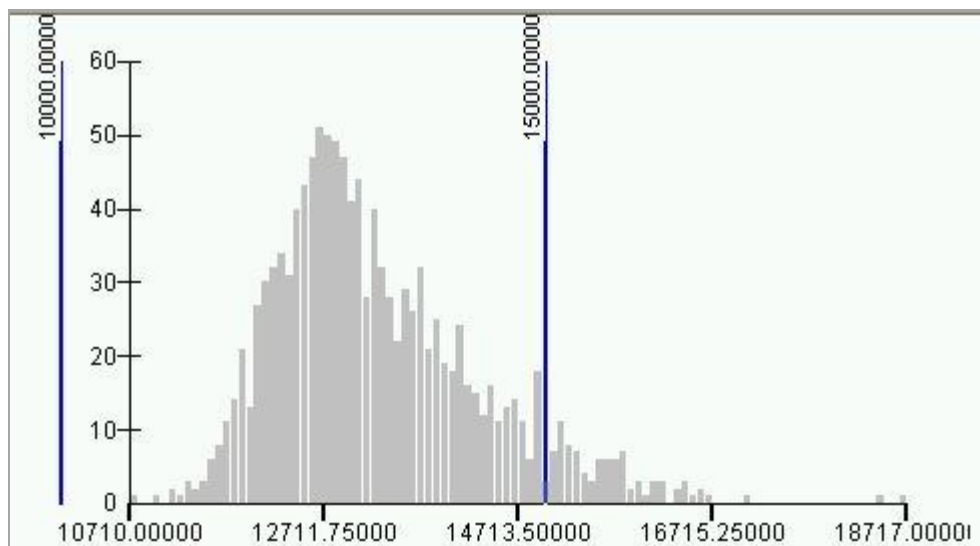
The following chart and statistics were generated by ESRI ArcGIS 9.3.1, and show the general distribution of the site gamma radiation measurements. The horizontal X axis represents the gamma radiation reading levels in cpm (lowest levels to the left). The vertical Y axis represents the frequency of each gamma radiation level.

Count:	1220
Minimum:	10710.00000
Maximum:	18717.00000
Sum:	16175685.00000
Mean:	13258.75820
Median:	13039.50000
Standard Deviation:	1058.48996

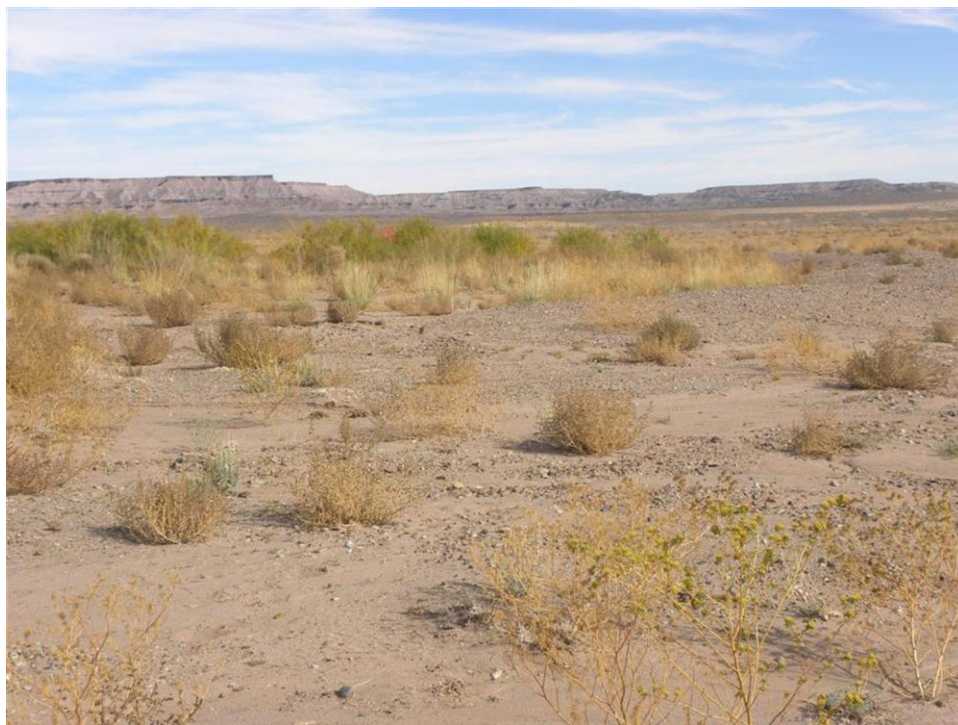
Photo 1. Harry Walker No. 16 mine site

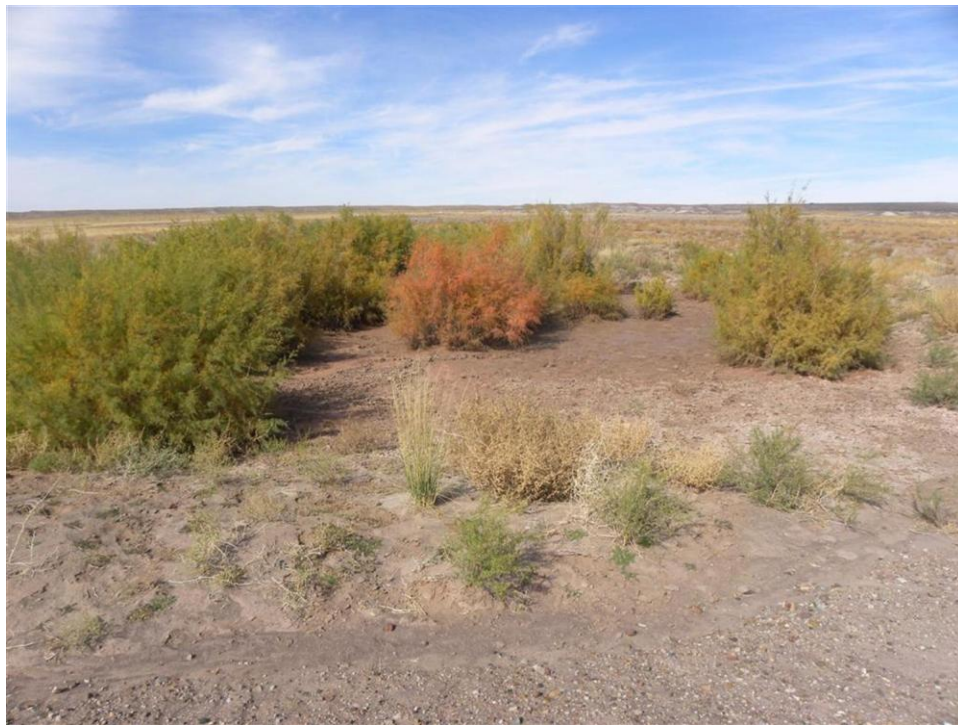
0 to 0.25 miles: Small pond in the center of the site, water maybe be attributable to flow from the north

Pond area had evidence of livestock (cattle, horses)

Photo 2. Harry Walker No. 16 mine site, small pond area

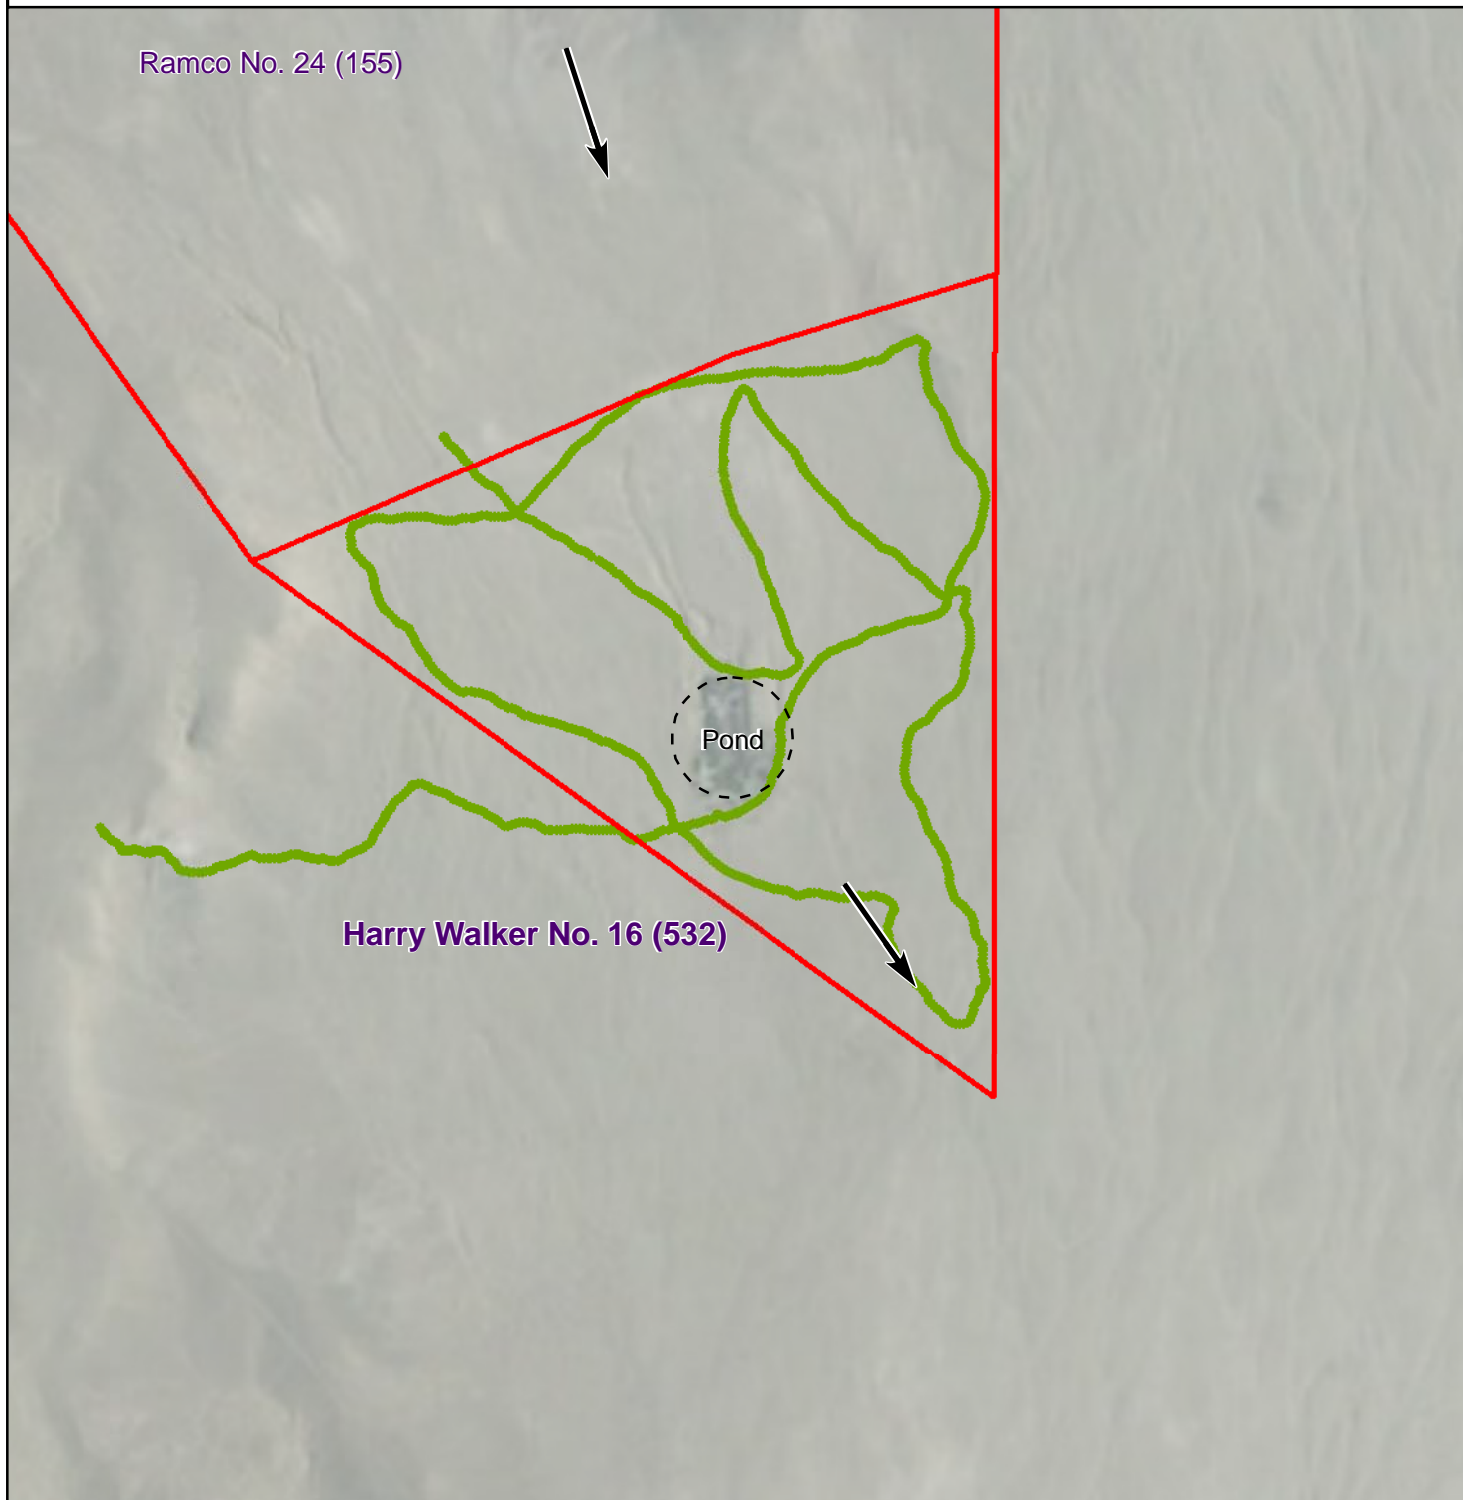
**Figure 1 - Gamma Radiation Measurements, Above Two Times Background
Ramco No. 24 (155)
Coalmine Mesa Chapter, Navajo Nation**

A total of 1,220 gamma radiation measurements were collected from the mine site, ranging from 10,710 cpm to 18,717 cpm. The measurements are represented in Figures 1 and 2.

Gamma survey conducted 11/2010
Measured as counts per minute (cpm)

Average background 12,341 cpm

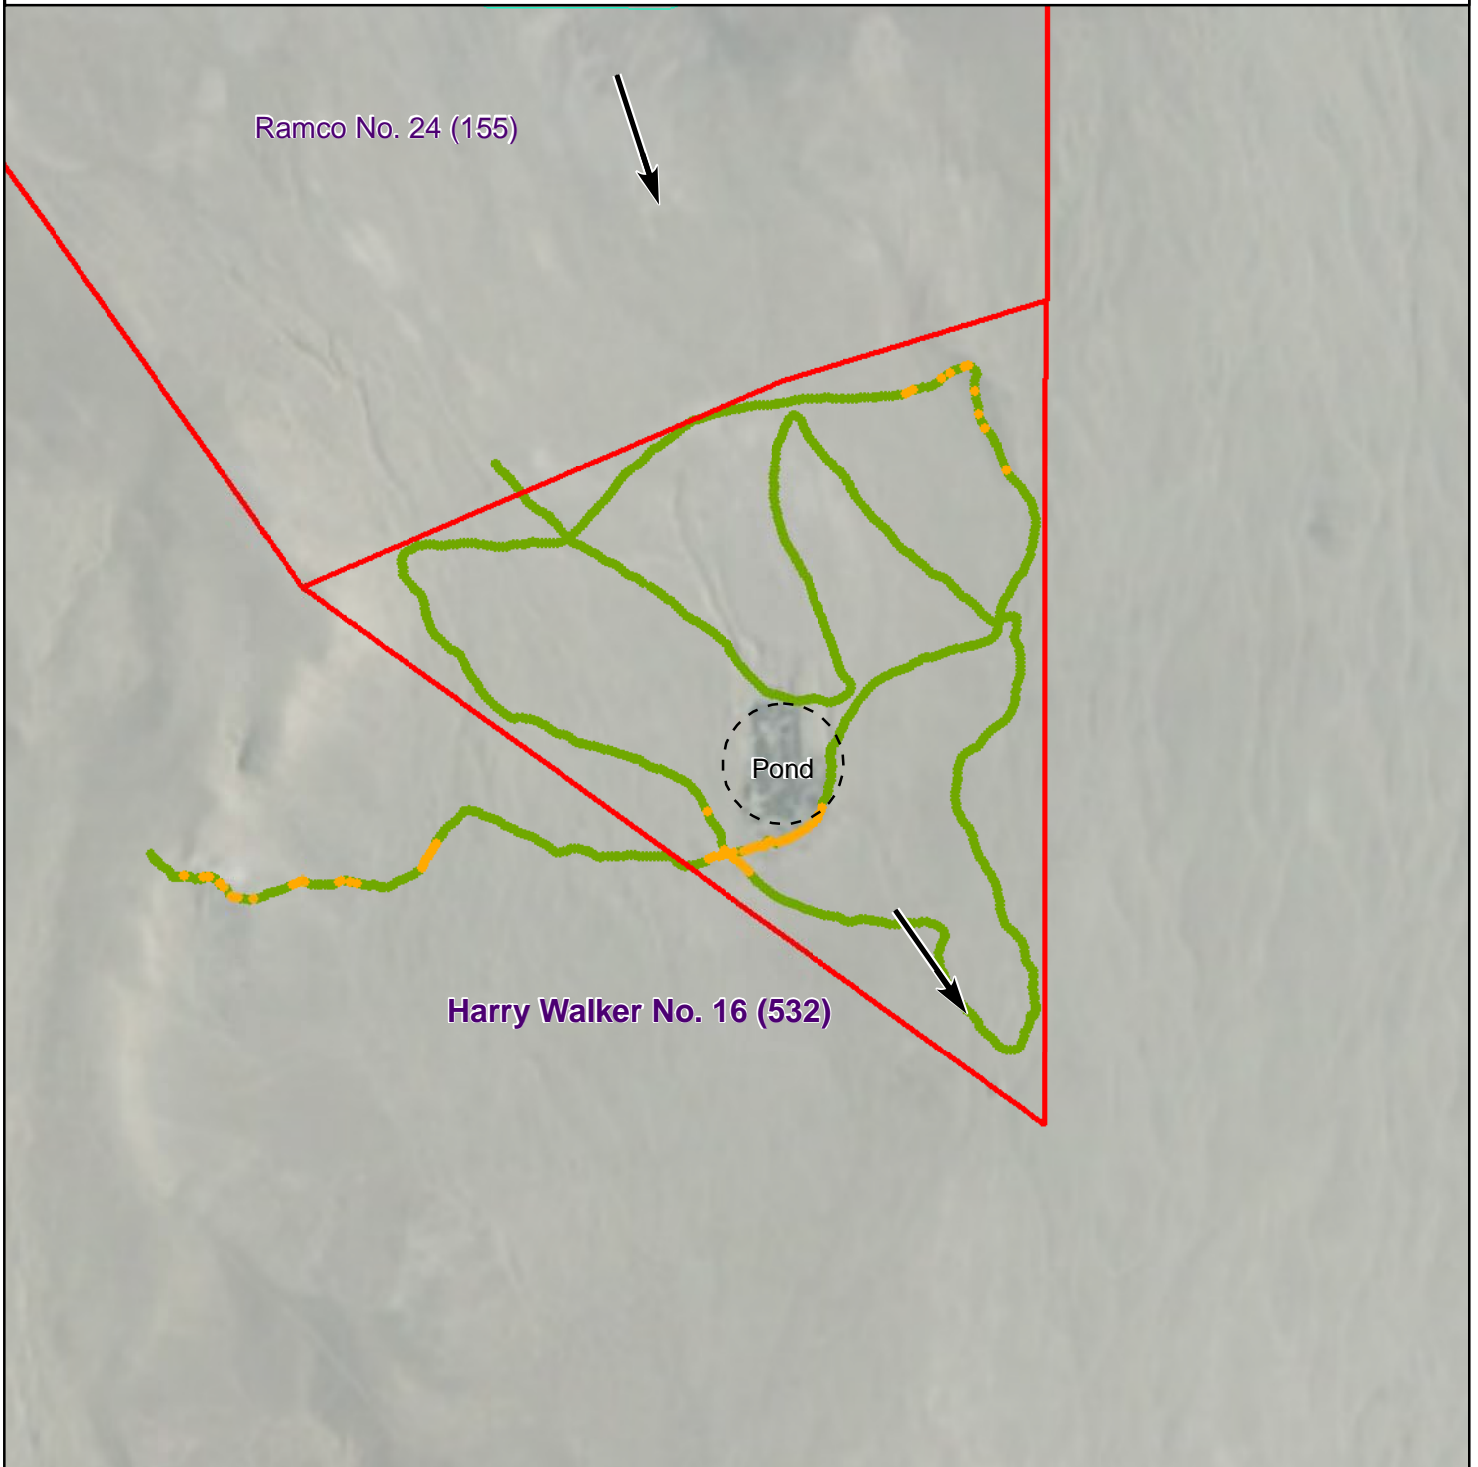
Figure 2 - Gamma Radiation Measurements
Ramco No. 24 (155)
Coalmine Mesa Chapter, Navajo Nation

Gamma survey conducted 11/2010
Measured as counts per minute (cpm)

Average background 12,341 cpm
